Health Monitoring of LAV Planet Gear Bushings using Signature Analysis Techniques

**MASTER OF SCIENCE
IN
MECHANICAL ENGINEERING**

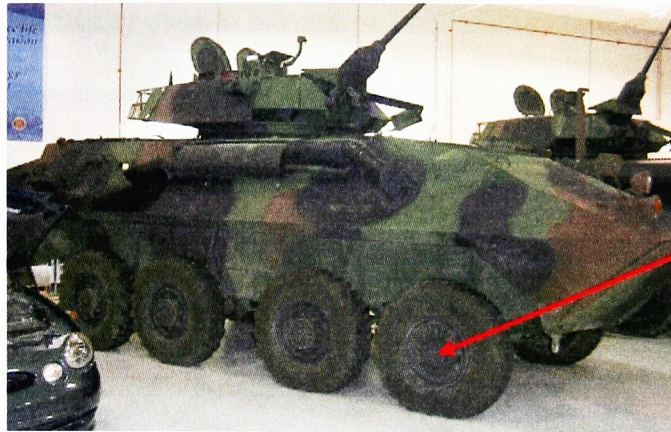
Figure 1. Photograph of LAV-25

When completely loaded for combat, the LAV-25 weighs 28,400 lb [32]. It is approximately 21 feet long, 8 feet wide, and 8 feet high [32]. It is capable of transporting three crewmembers and six troops [32].

Planetary
assembly exists
in each wheel
hub

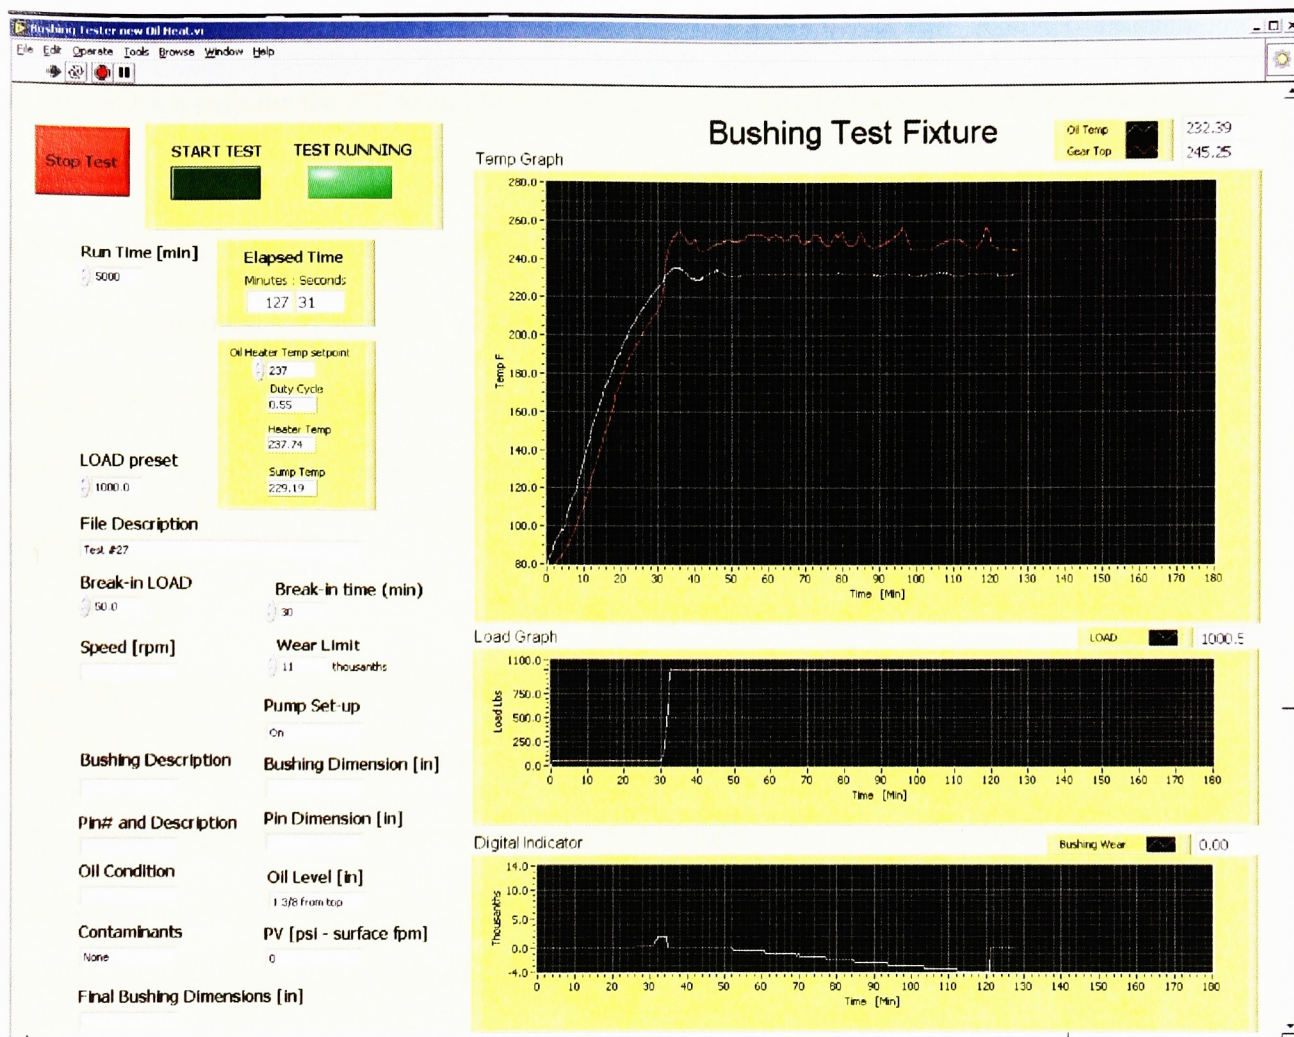
The graphical coding software LabVIEW (National Instruments, Austin, TX) is used to automatically control the BT system. Parameters such as temperature, load, operating time, operational limits, file name, and others are controlled with the user interface panel depicted below in Figure 22.

Figure 22. User Interface Panel for Data Acquisition Control

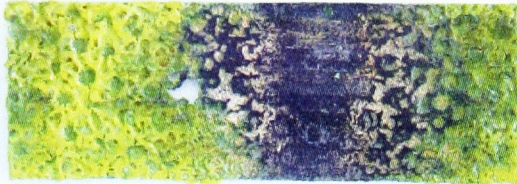
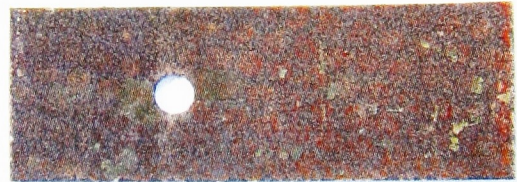
therefore bushing) is rotating around the pin. The BT, however, was designed so that the pin is actually rotating inside of the bushing. This results in localized bushing wear due to the radial load. Figures 23a and 23b below show the difference in wear that results from an LAV-worn bushing and a BT-worn bushing.

Figure 23a. BT-worn Bushing

Figure 23b. LAV-worn Bushing

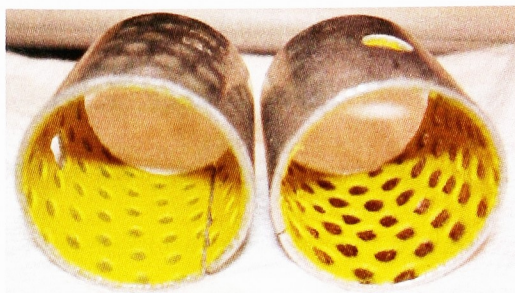
Figure 38b. Enlarged bushing dimples, Photo 2

Three RTF tests were conducted using bushings with enlarged dimples (Figures 38a and 38b). The size of the dimples was increased manually by the author using a Dremel® tool (3/32-inch spherical grooved end tool). The precise circular geometry of the bushing dimples could not be accurately maintained with the Dremel® tool. This was considered acceptable, however, since the desired result of these tests is to determine the (qualitative) effect, if any, of dimple geometry on the bushing signature.
